# GHG SRP Current and Completed Projects MATR-3-15A/B

MATR-3-15A: Assessment of Nonwelded Repair Methods to Reduce Pipeline Blowdowns  
and  
MATR-3-15B: Industry Best Practices for Making Nonwelded Repairs Permanent

Melissa Gould, DNV

15 October 2024

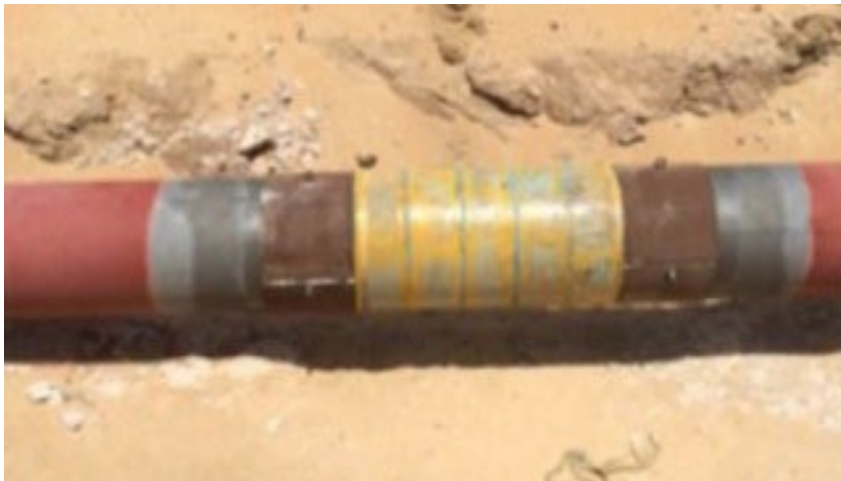
Adjacent tight-fitting sleeves installed

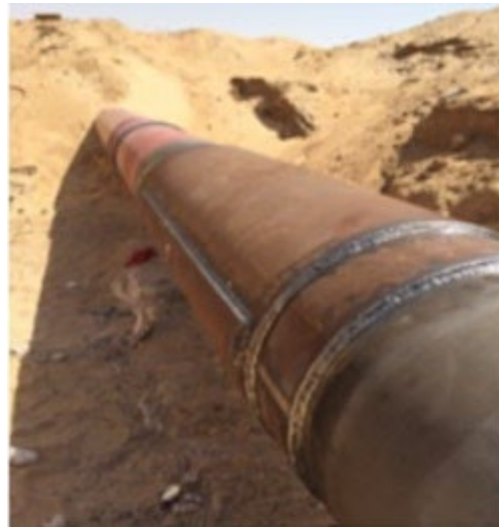
Backing strip behind longitudinal seam of over-sleeve

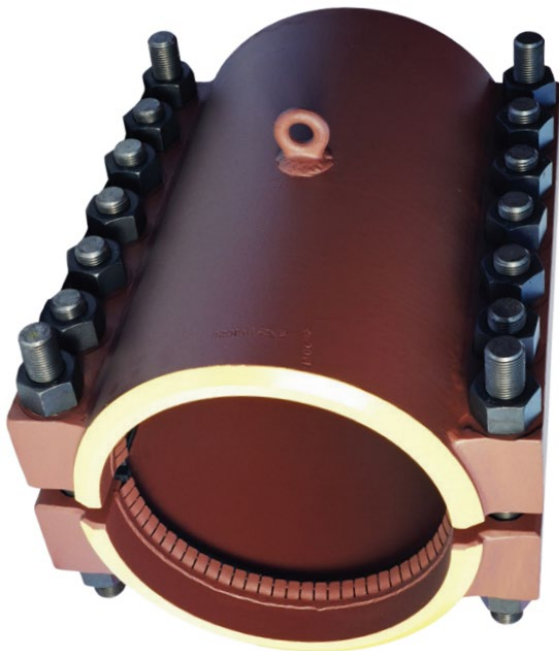
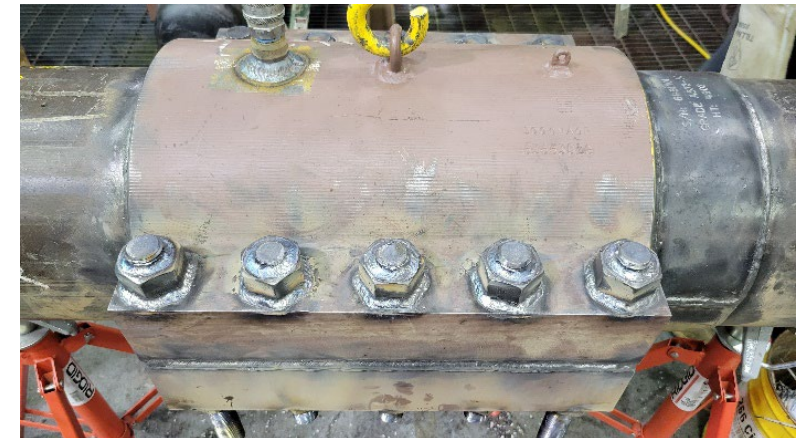
# MATR-3-15B Welding of a Mechanical Bolt-On Clamp

- Split+Sleeve fittings will be donated to the project by PLIDCO
  - Fittings will be welded to a pressurized pipe to validate the life extension concept and develop industry best practices
    - Investigate thermal severity (water vs. air), accommodate end gap/gross thickness change, and preheat the stud-to-nut and nut-to-fitting welds
    - Vessel will remain pressurized overnight after welding, inspection performed (after suitable delay), and sectioning/analysis of the welds and seals will be undertaken

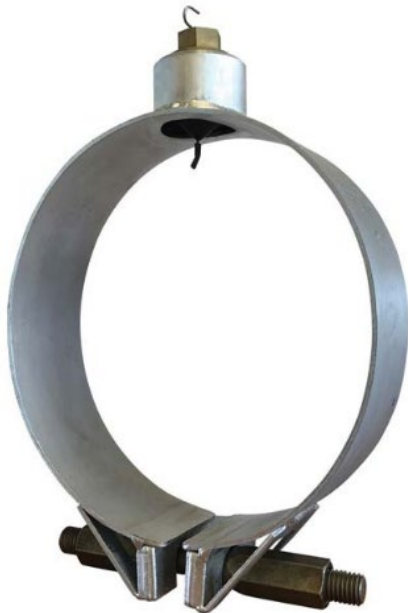
# MATR-3-15B Welding of a Leak Clamp

- Smith+Clamp and Weld+Caps will be donated to the project by PLIDCO
  - Weld a Weld+Cap over the force screw and sealing core, removing the draw band, to develop industry best practices
  - Vessel will remain pressurized overnight after welding, inspection performed (after suitable delay), and sectioning/analysis of the welds and seals will be undertaken
